*Airfield Damage Repair Modernization Program*

## **AM2 Mat End Connector Modeling and Performance Validation**

August 2015

Final report

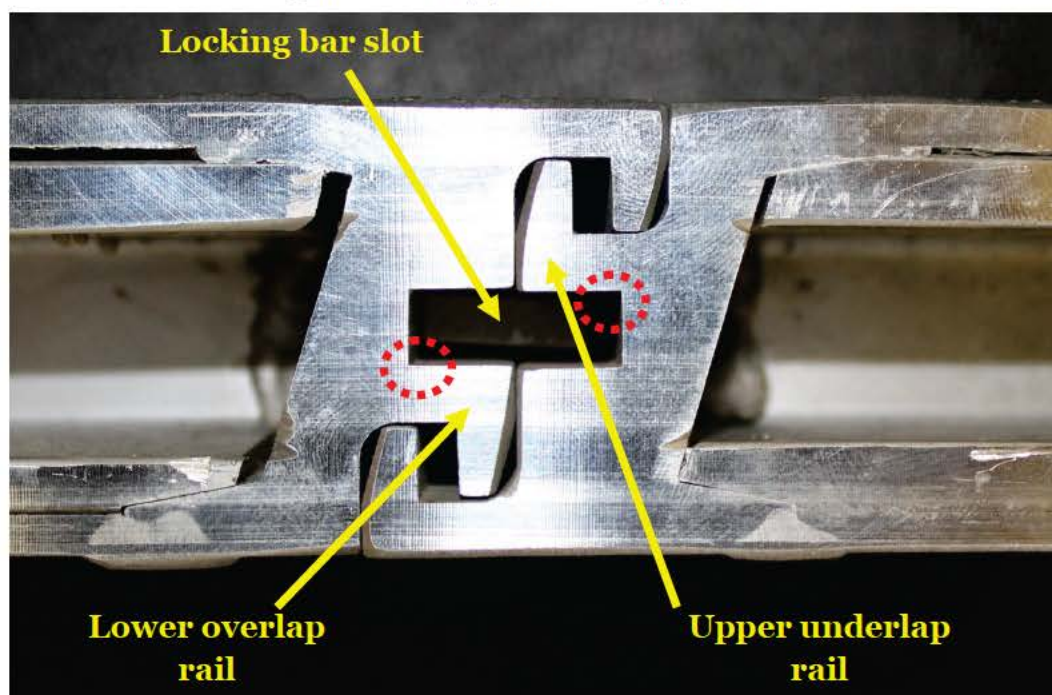
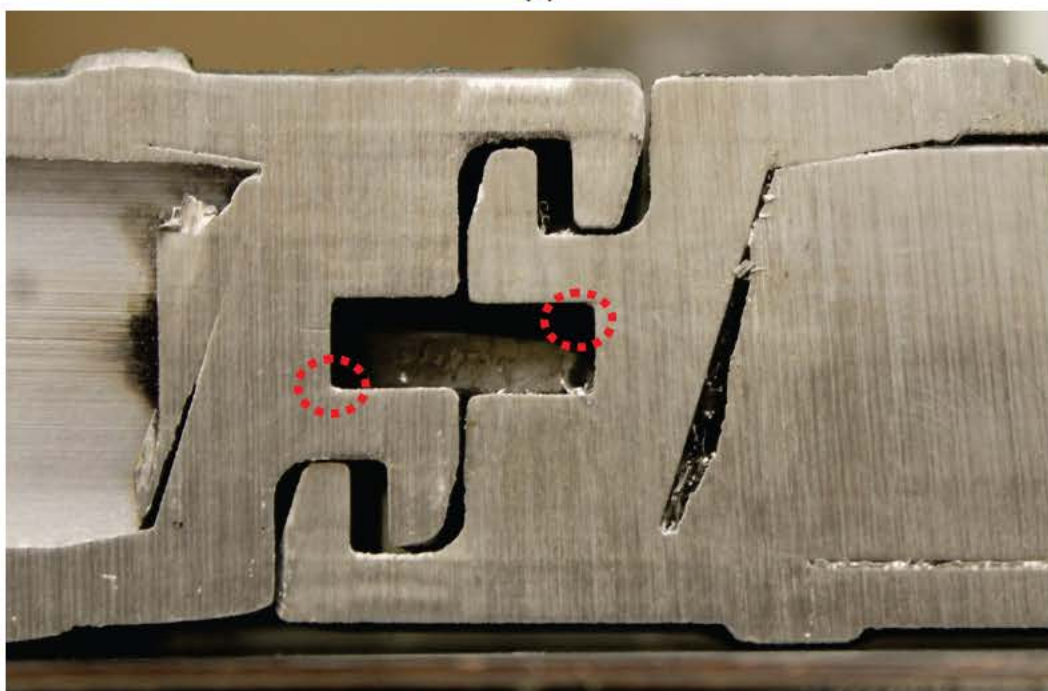
After completion of the test program, a thorough investigation of both the subgrade and the mat revealed that the manufacturer's drawing used for the extrusion die for the AM2 end connector inadvertently omitted filleted corners in the locking bar channel. As shown in Figure 1, this location is the smallest cross-sectional area of the rail.

Figure 1. Corners (a) without fillet; (b) with fillet.

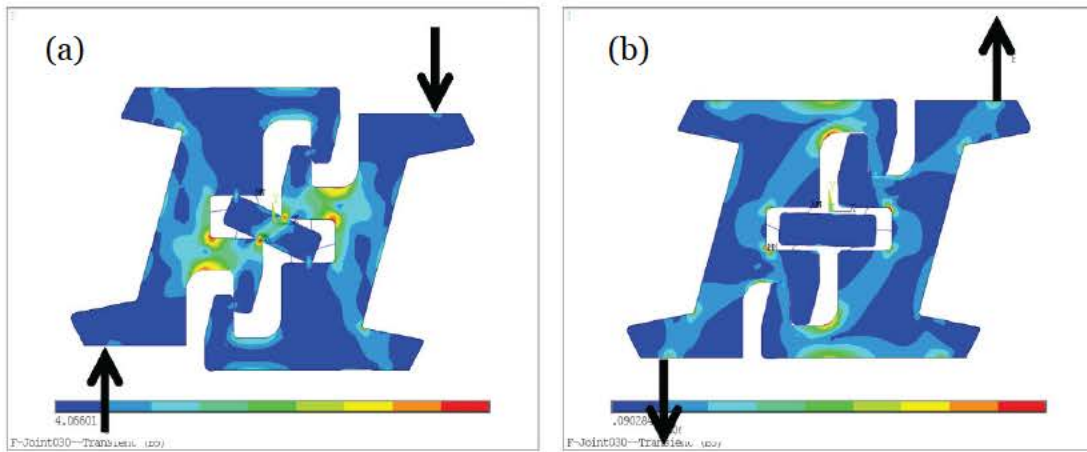
Several modeling efforts showed that these corners were areas of high stress concentration, shown in Figure 2. In Figure 2a, the load (i.e., F-15E tire load) is applied on the right side of the joint. In this case, the load is transferred to the lower overlap rail through the locking bar, and a high tensile stress is shown at the corner adjacent to each rail. In Figure 2b, the load is applied on the left side of the joint. In this case, the loading results in a compressive stress at the internal rail radii at the locking bar corners. In both cases, critical stresses developed at the locations shown in Figure 1, which is consistent with rail breakage commonly reported by Rushing and Tingle (2007), Rushing and Torres (2007), Rushing et al. (2008), Rushing and Mason (2008), and Garcia and Rushing (2013). An example of crack initiation at one of the corners is shown in Figure 3.

Figure 2. AM2 joint modeling analysis: (a) load on right side; (b) load on left side.

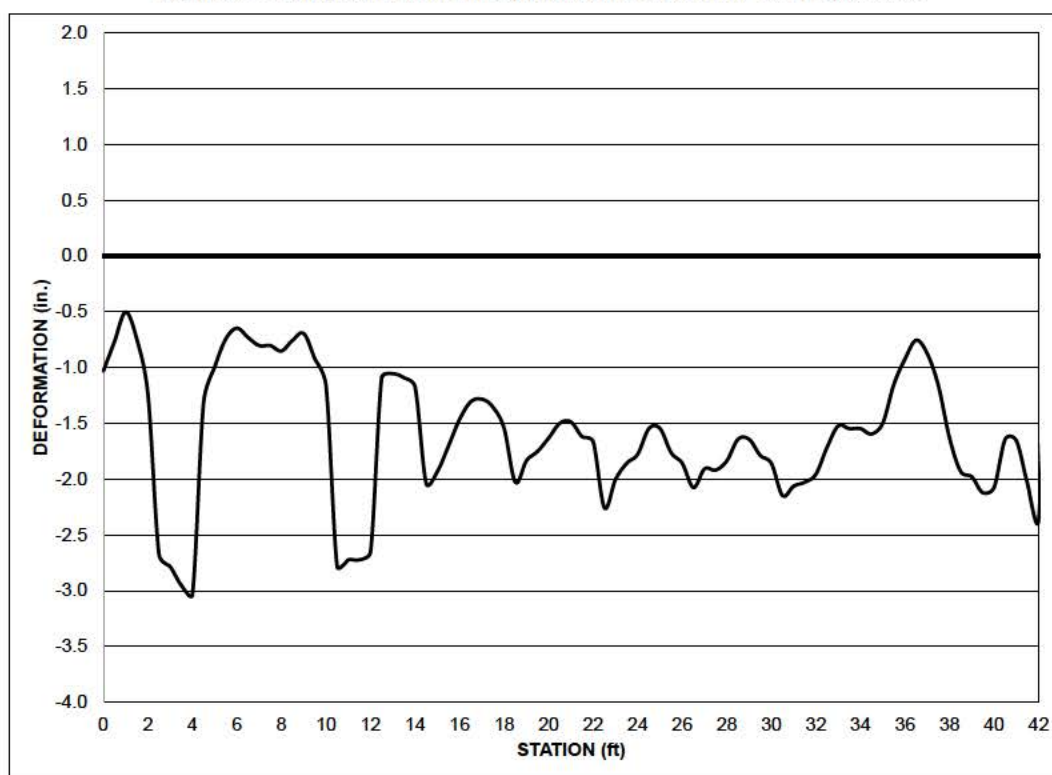
In Item A, stations 2 to 4 and stations 10 to 12 were areas of panel end connector rail failure and are represented as deep depressions in the subgrade (Figures 38). These were disregarded when analyzing the profile since they were associated with mat breakage and not necessarily with the system's ability (or inability) to prevent excessive roughness. As shown in Figures 39 and 41, the same is true for stations 14 to 16 in Item B. Buildup of material also occurred beneath the plate placed above panels I-17 and I-18 (about stations 6 to 8); therefore, the change in elevation from stations 8 to 10 in Figure 39 would appear to be the maximum roughness value. This was also disregarded when analyzing the subgrade profile, since it was associated with the metal plate placed above the mat surface and not with the performance of the system itself.

Figure 38. Subgrade centerline profile of Item A after 1,008 passes.

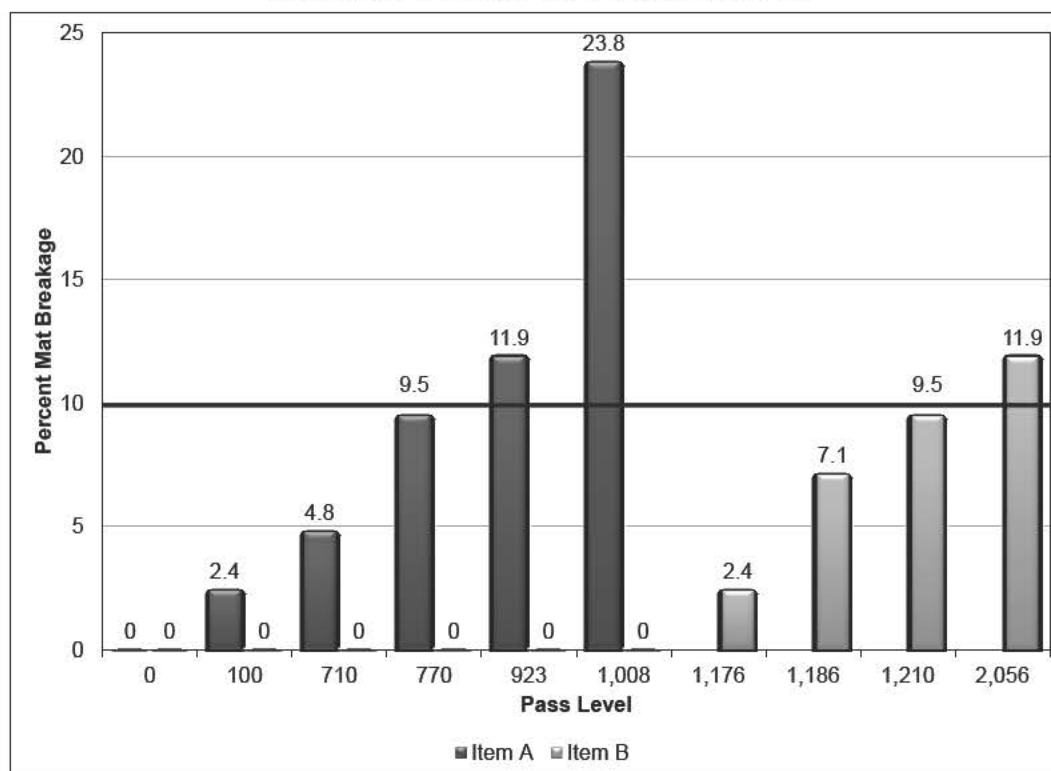
A summary of the progression of mat breakage for each test item is shown in Figure 50 for comparative purposes. Item A and Item B were able to sustain 923 passes and 2,056 passes, respectively, before failure by mat breakage. Two important things to note from Figure 50 are (1) panel failures in Item B started to occur about 250 passes after Item A was rated as failed and (2) at the end of each test, percent mat breakage in Item A was twice the amount noted in Item B. A comparison of the number of occurrences of the different failure mechanisms in each test item is provided in Table 10. Mat breakage in both test items was typical and similar to that reported by Rushing and Tingle (2007), Rushing and Torres (2007), Rushing et al. (2008), Rushing and Mason (2008), and Garcia and Rushing (2013) in AM2 when trafficked over weak subgrade conditions. End connector rail failures were the most common mechanism of mat breakage reported by these authors.

Figure 50. Comparison of percent mat breakage.
